PBY Catalina

Walk Around

By William Scarborough

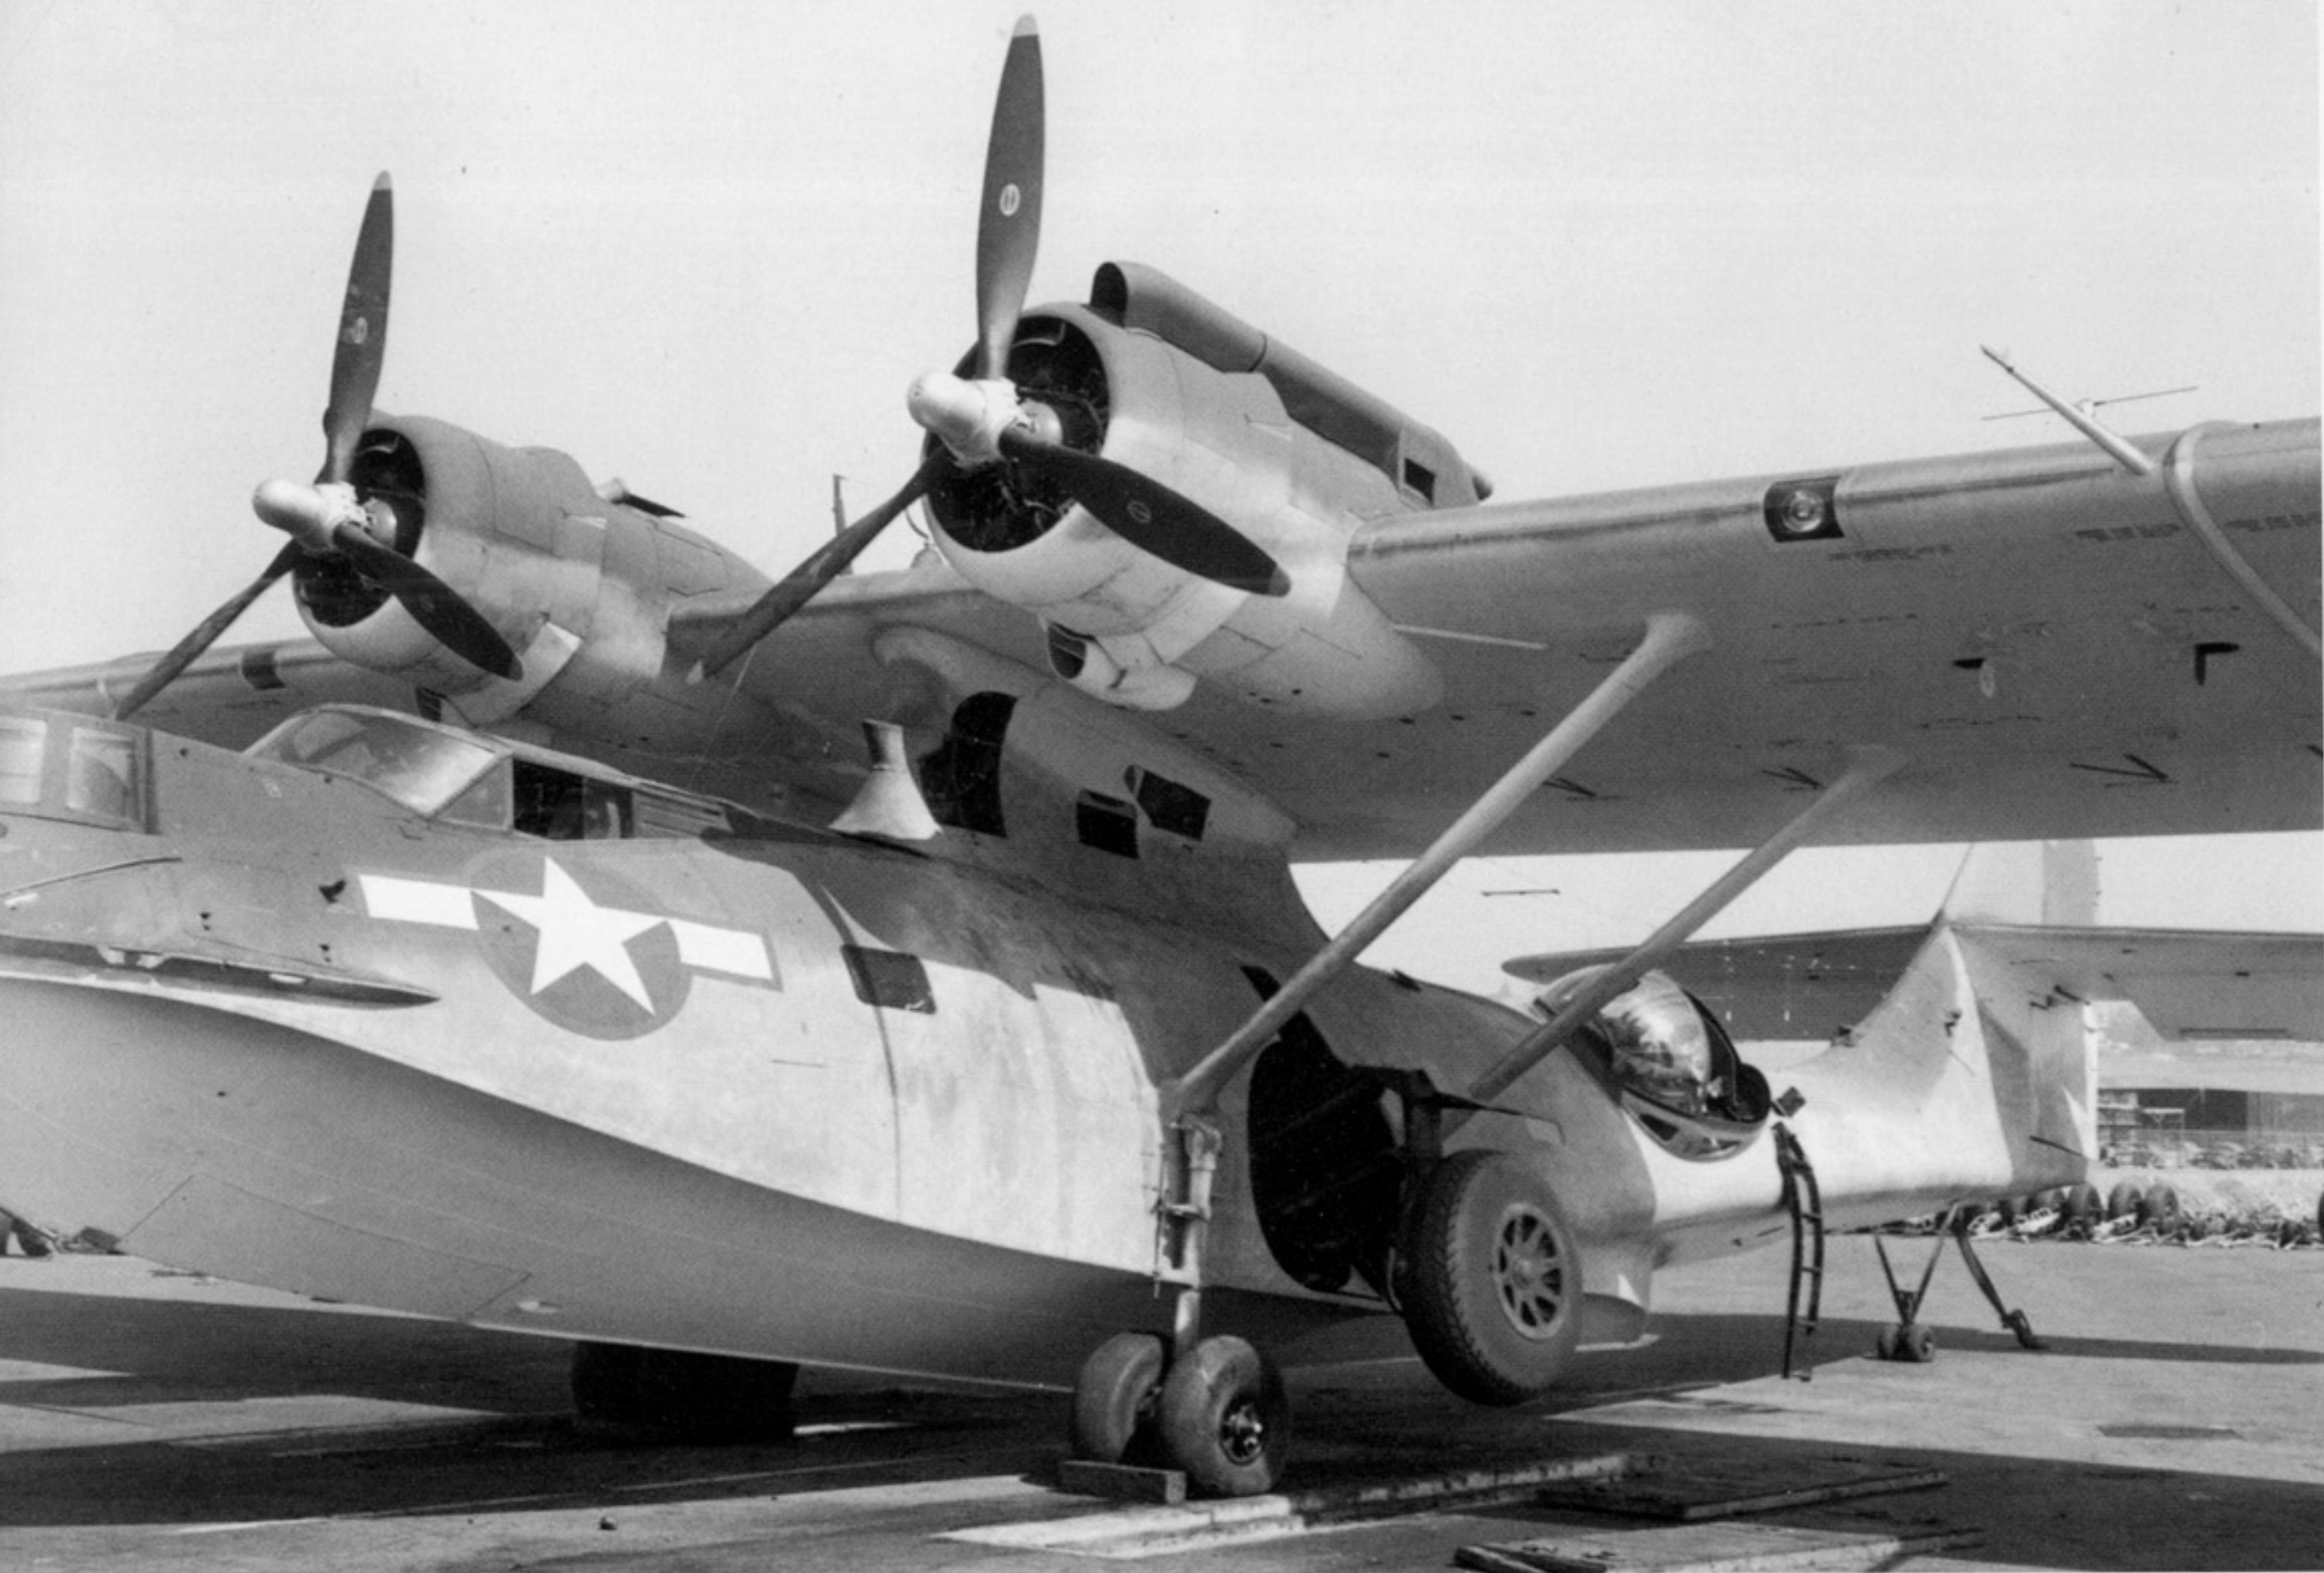
PBX-5A landing gear maintenance was frequently accomplished by installation of beaching gear and parking the aircraft adjacent to a pit, instead of using lifting jacks. The housing above the engine nacelle covered the heat exchanger for the wing thermal deicing system. The air intake for the gasoline-fueled tail thermal deicing system is visible on the lower leading edge of the fin. (CAC)

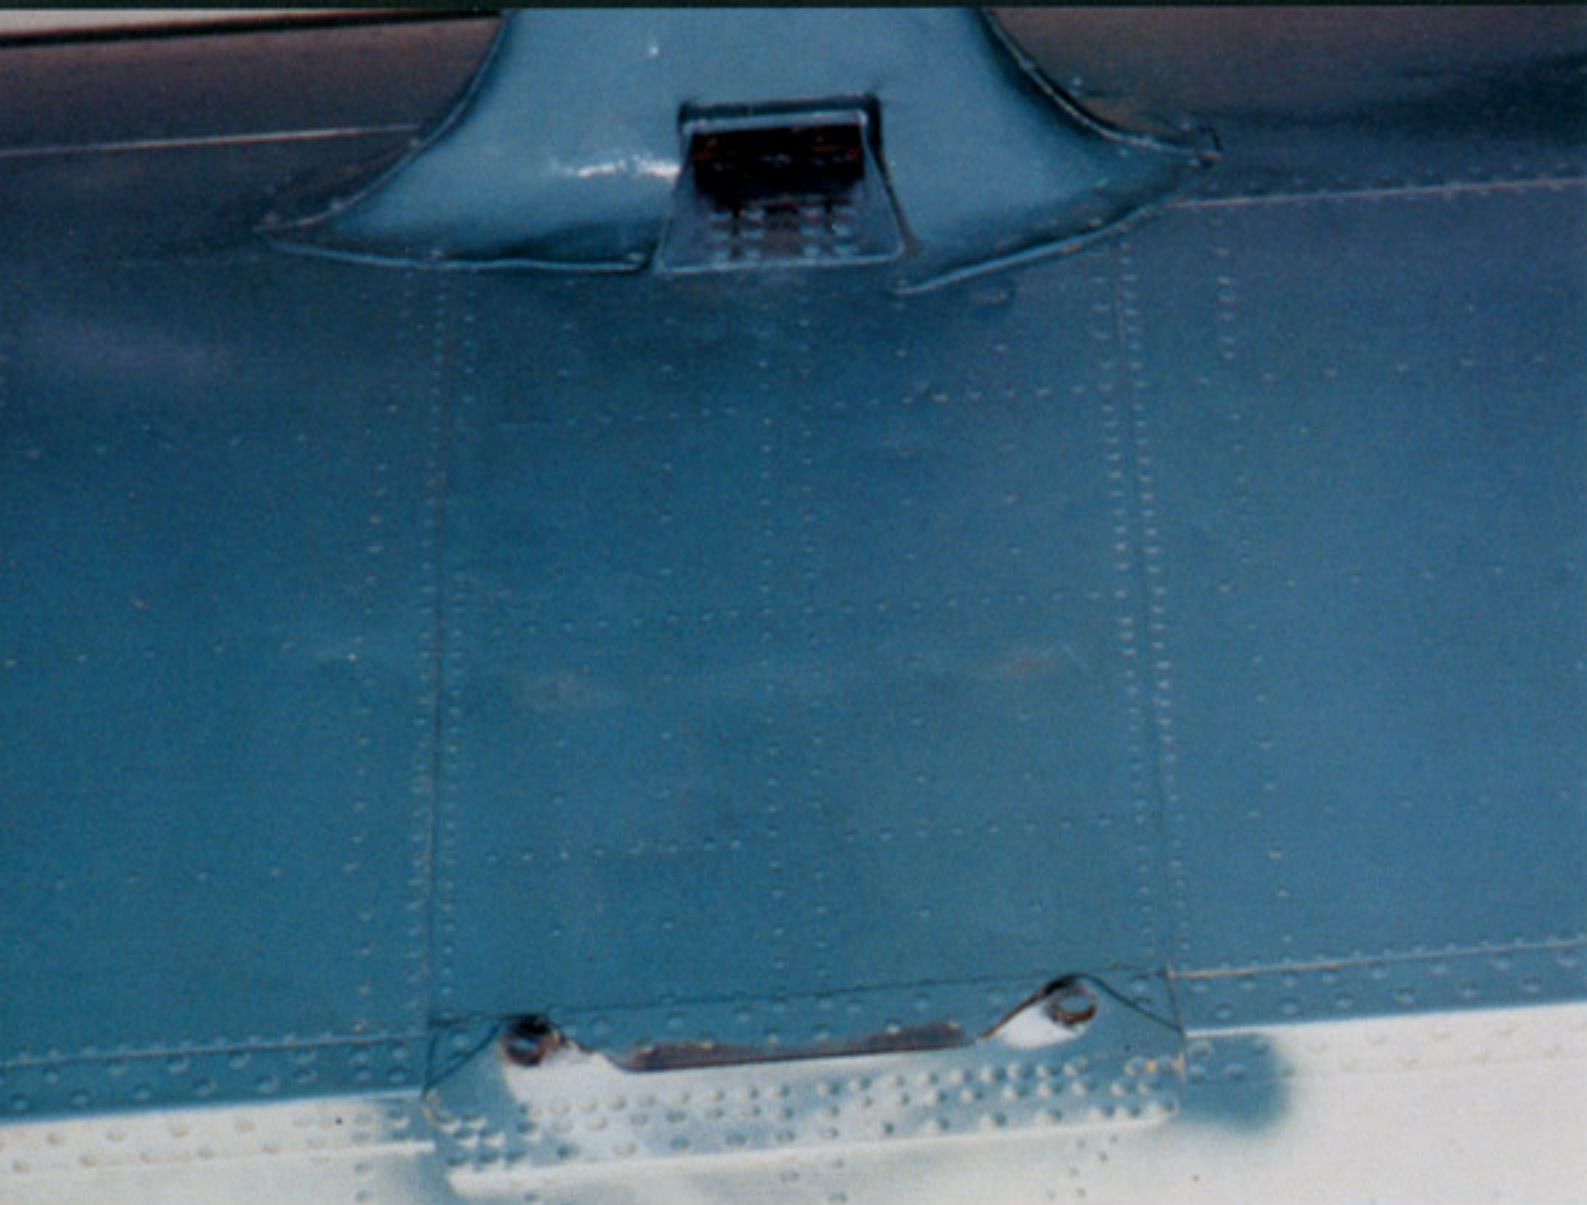
The starboard main beaching gear hull attachment sockets of the PBY-5 at the National Museum of Naval Aviation. (Ross Creed)

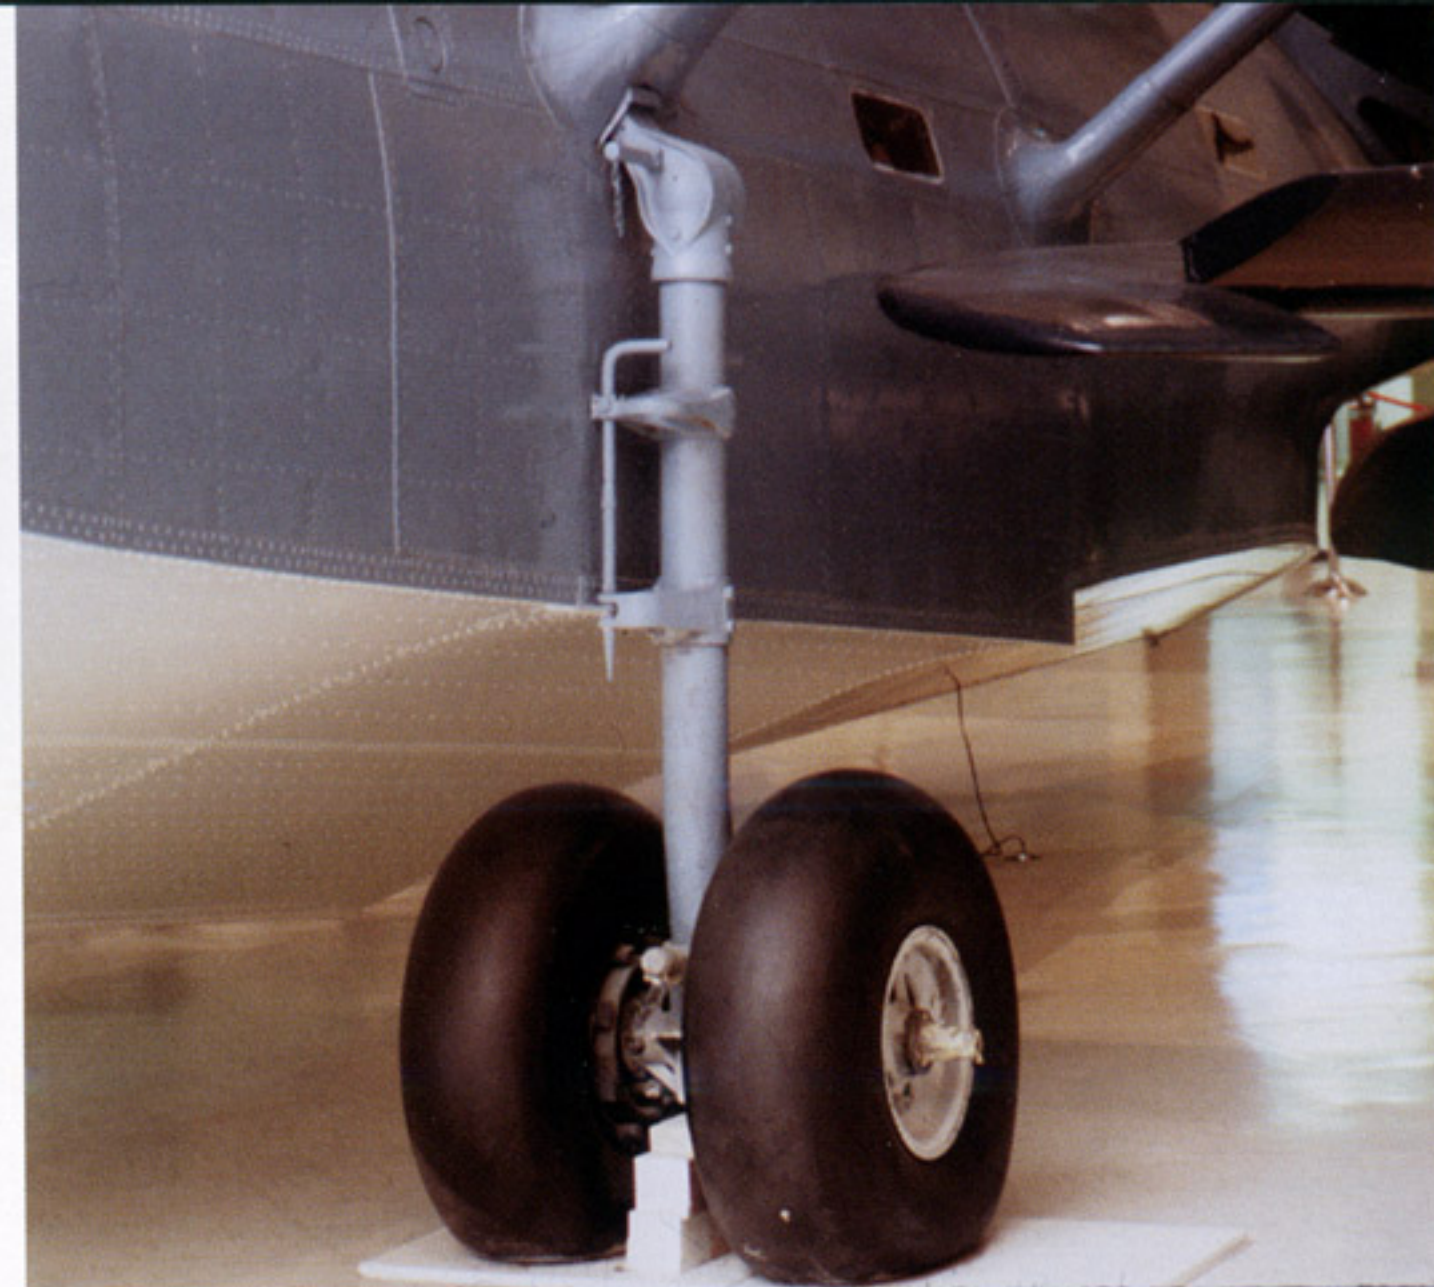
The port main beaching gear in place on the PBY-5 at the National Museum of Naval Aviation. The main beaching gear strut was temporary up on blocks. (WES)

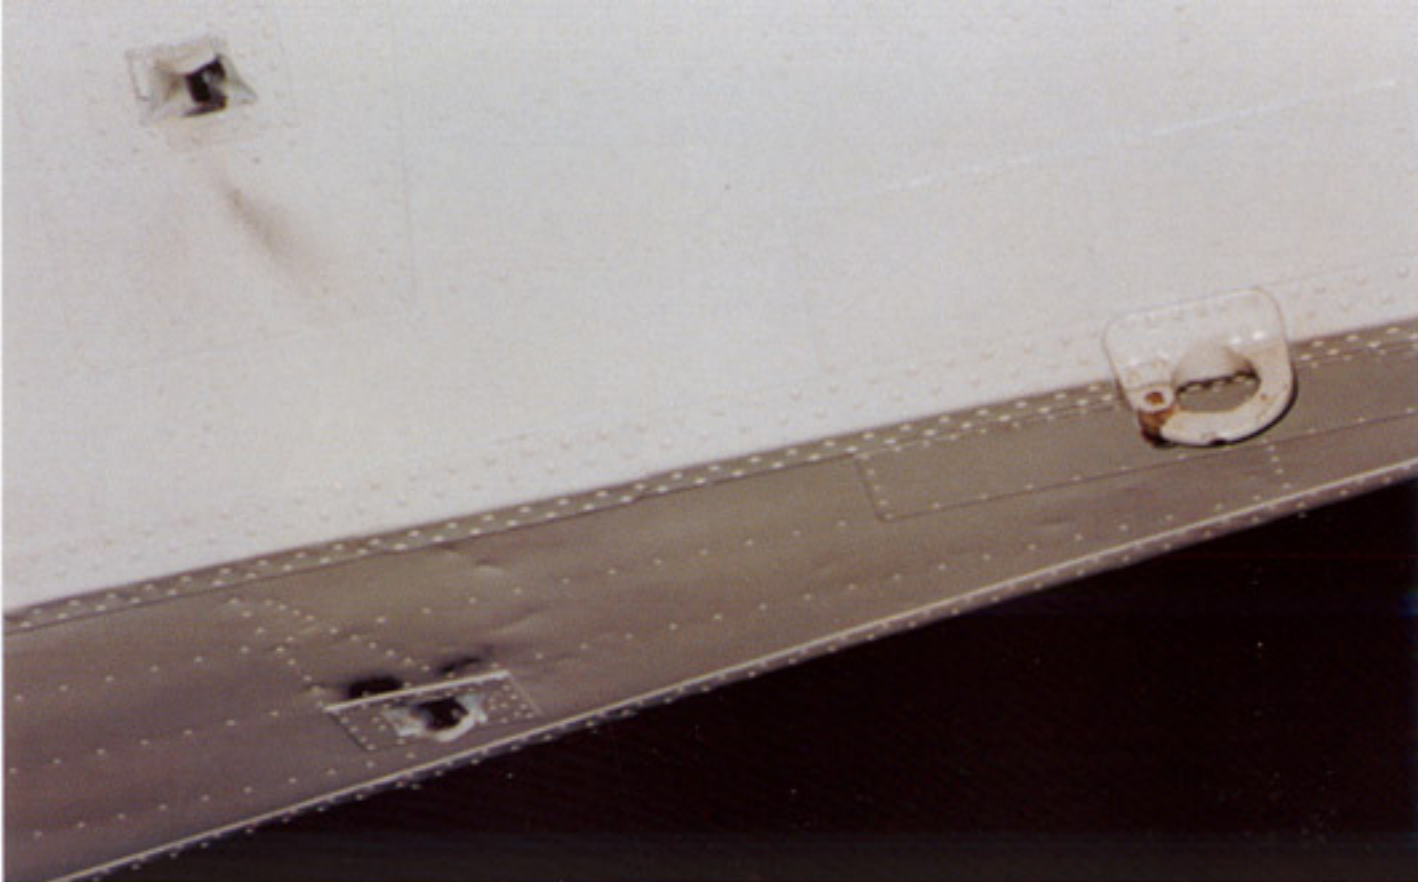
The two mounting sockets for tail beaching gear struts were located on the bottom of the rear hull. (WES)

Removing and reattaching beaching gear posed many of the least desirable aspects of seaplane operations. For launching and recovering the P-boats, the U.S. Navy developed over the years many operating techniques based primarily on the use of beaching crews. For PBYs, crews generally had 6 or 7 men, two for each side mount, one at the tail to steer with the tail wheel tiller while it was moving on beaching gear, a safety watch ahead and a crew chief in charge. For launching, the crew followed the plane down the ramp into the water controlling its speed by the tractor tow line and by the side mount men with the brakes. Once afloat the Beachmaster signalled the men on the side mounts to pull the retaining pins. On release, the gear floated up and the men walked it back up the ramp. The man on the tail gear unpinned it and walked it up the ramp. When all were clear, the Beachmaster released the tow line and signalled the aircraft's crew to taxi clear of the ramp. Beaching a PBY was a far more demanding operation, especially in high wind and sea states. Many years of experience in handling seaplanes and flying boats produced techniques and equipment which made safe beaching practical but, unfortunately, space here is too limited to discuss them. Basically, all were developed to position the aircraft on the ramp and hold it there until the beaching gear was attached. (WES)

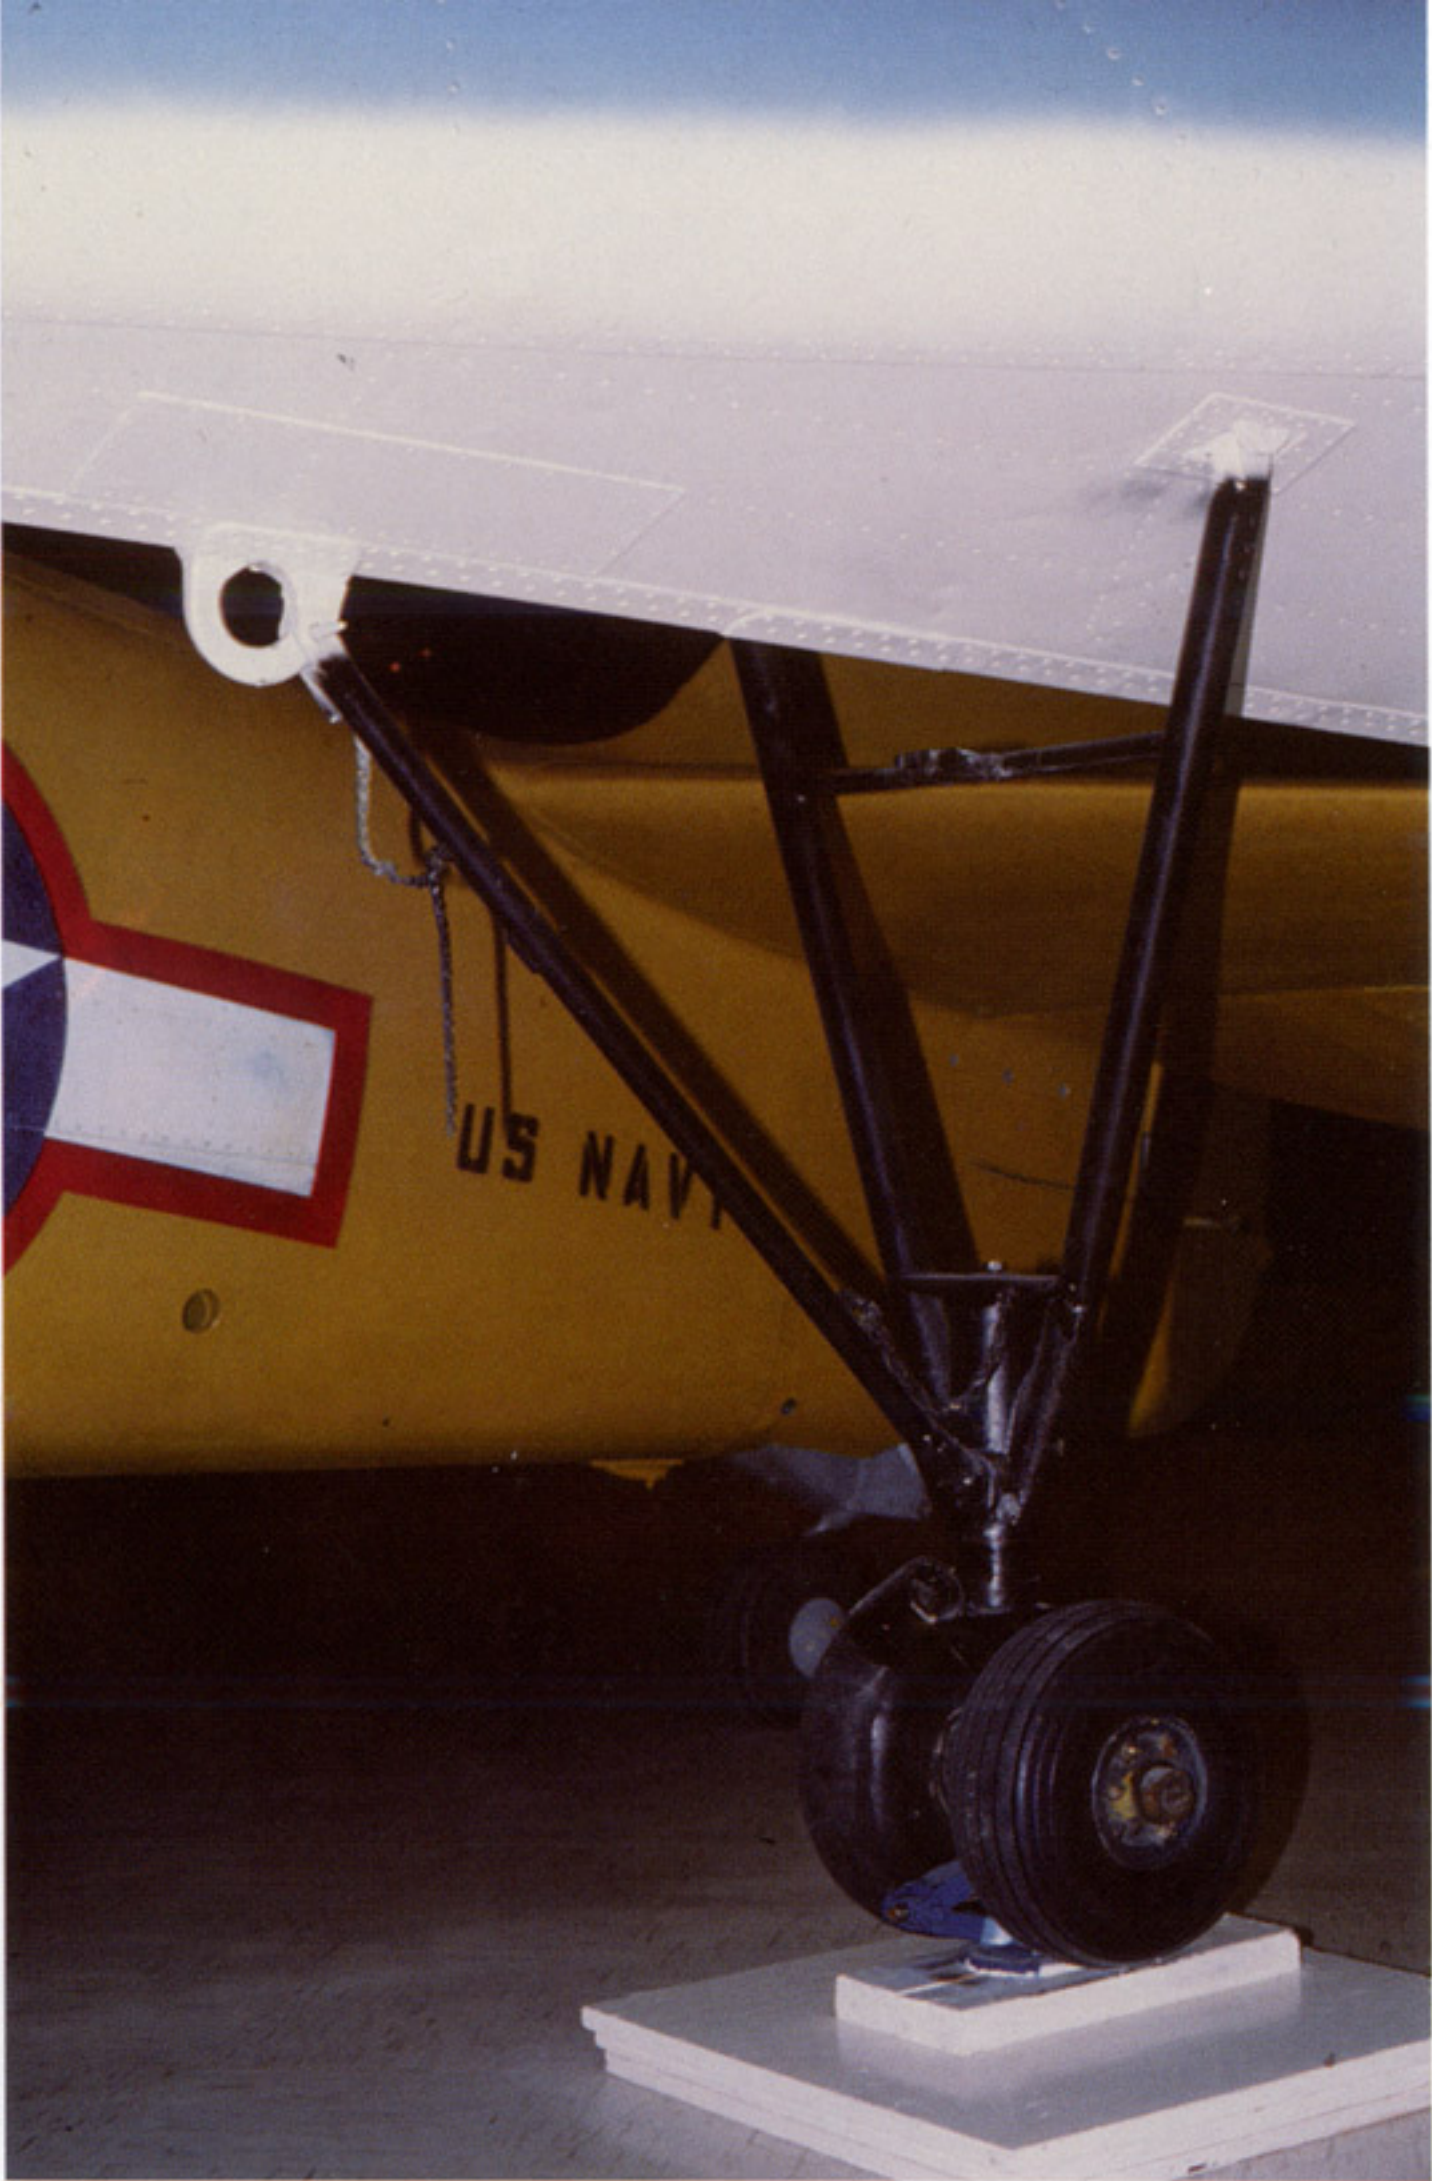
The tail beaching gear mounted on the hull of the PBY-5 at the Naval Aviation Museum at Pensacola, Florida, was up on temporary blocks. (WES)

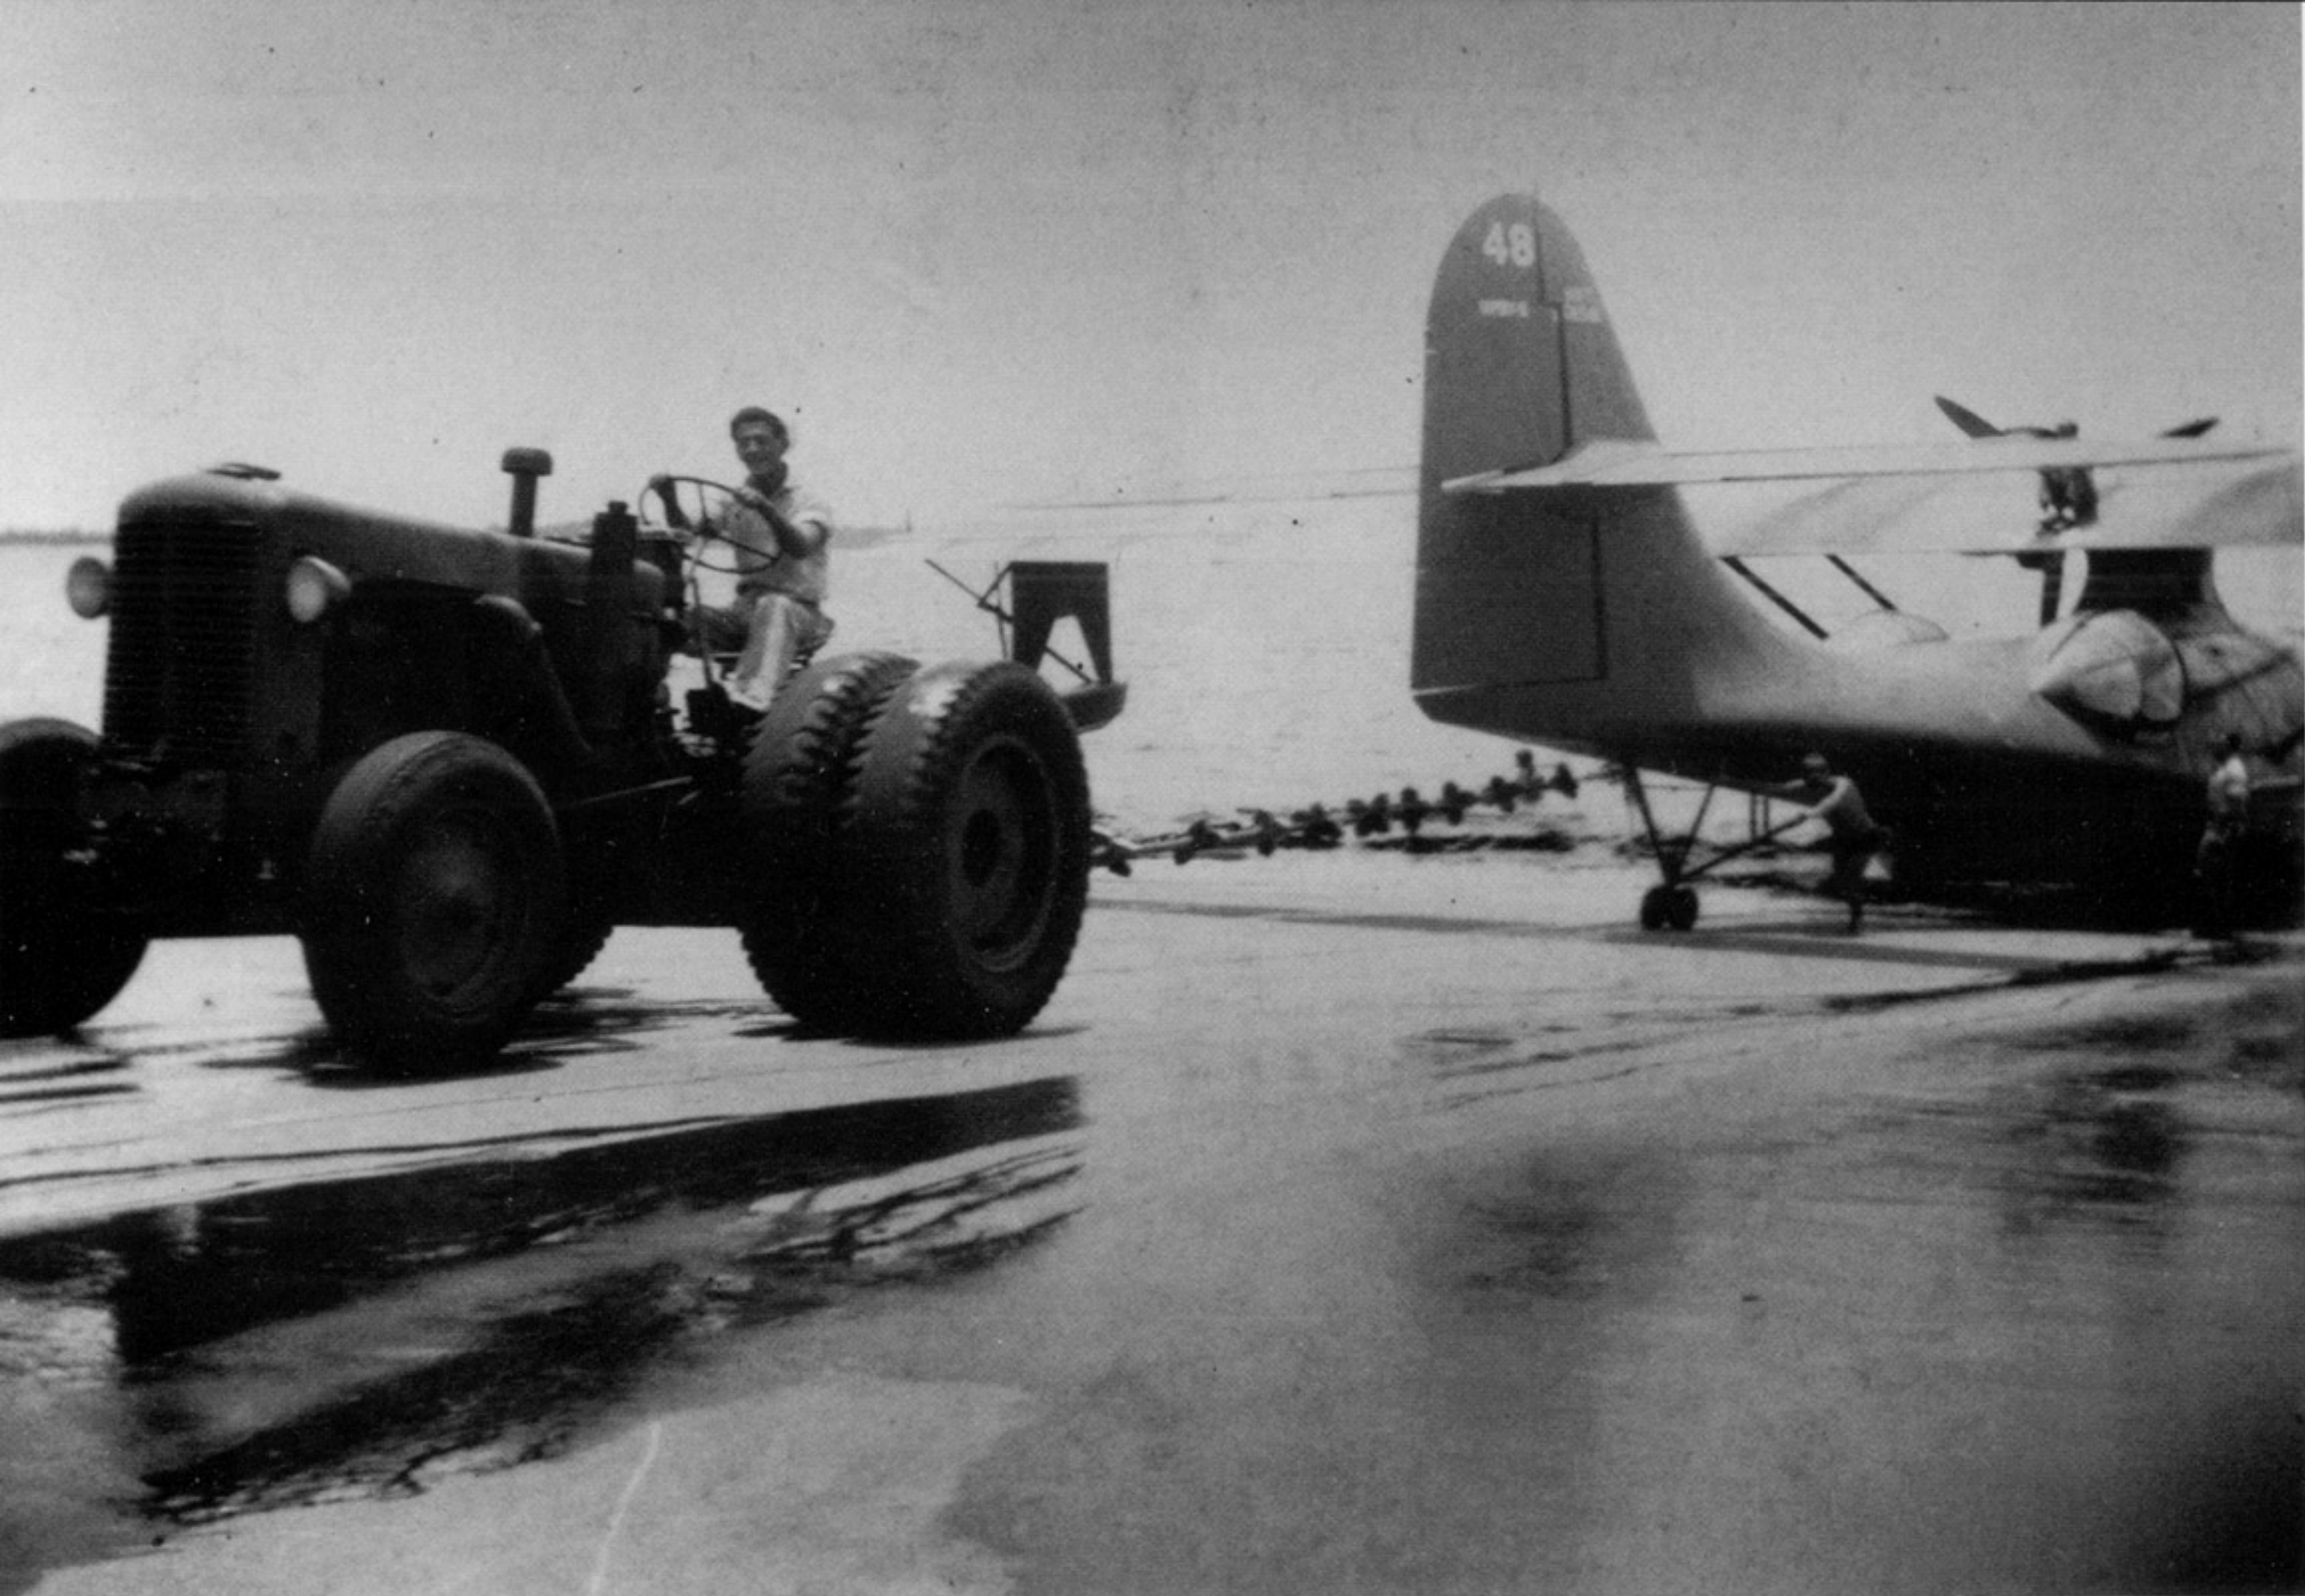
The beaching crew moves a SPBY-5 (BuNo 08318) of the Training Command up the seaplane ramp at Bronson Field, Pensacola, Florida, during 1946 . The prefix "S" in the designator on the tail has not been identified. The beach crewman at the aircraft's tail steered the PBY, using the beaching gear tiller as it was towed up the ramp. (P. Fackler via R.

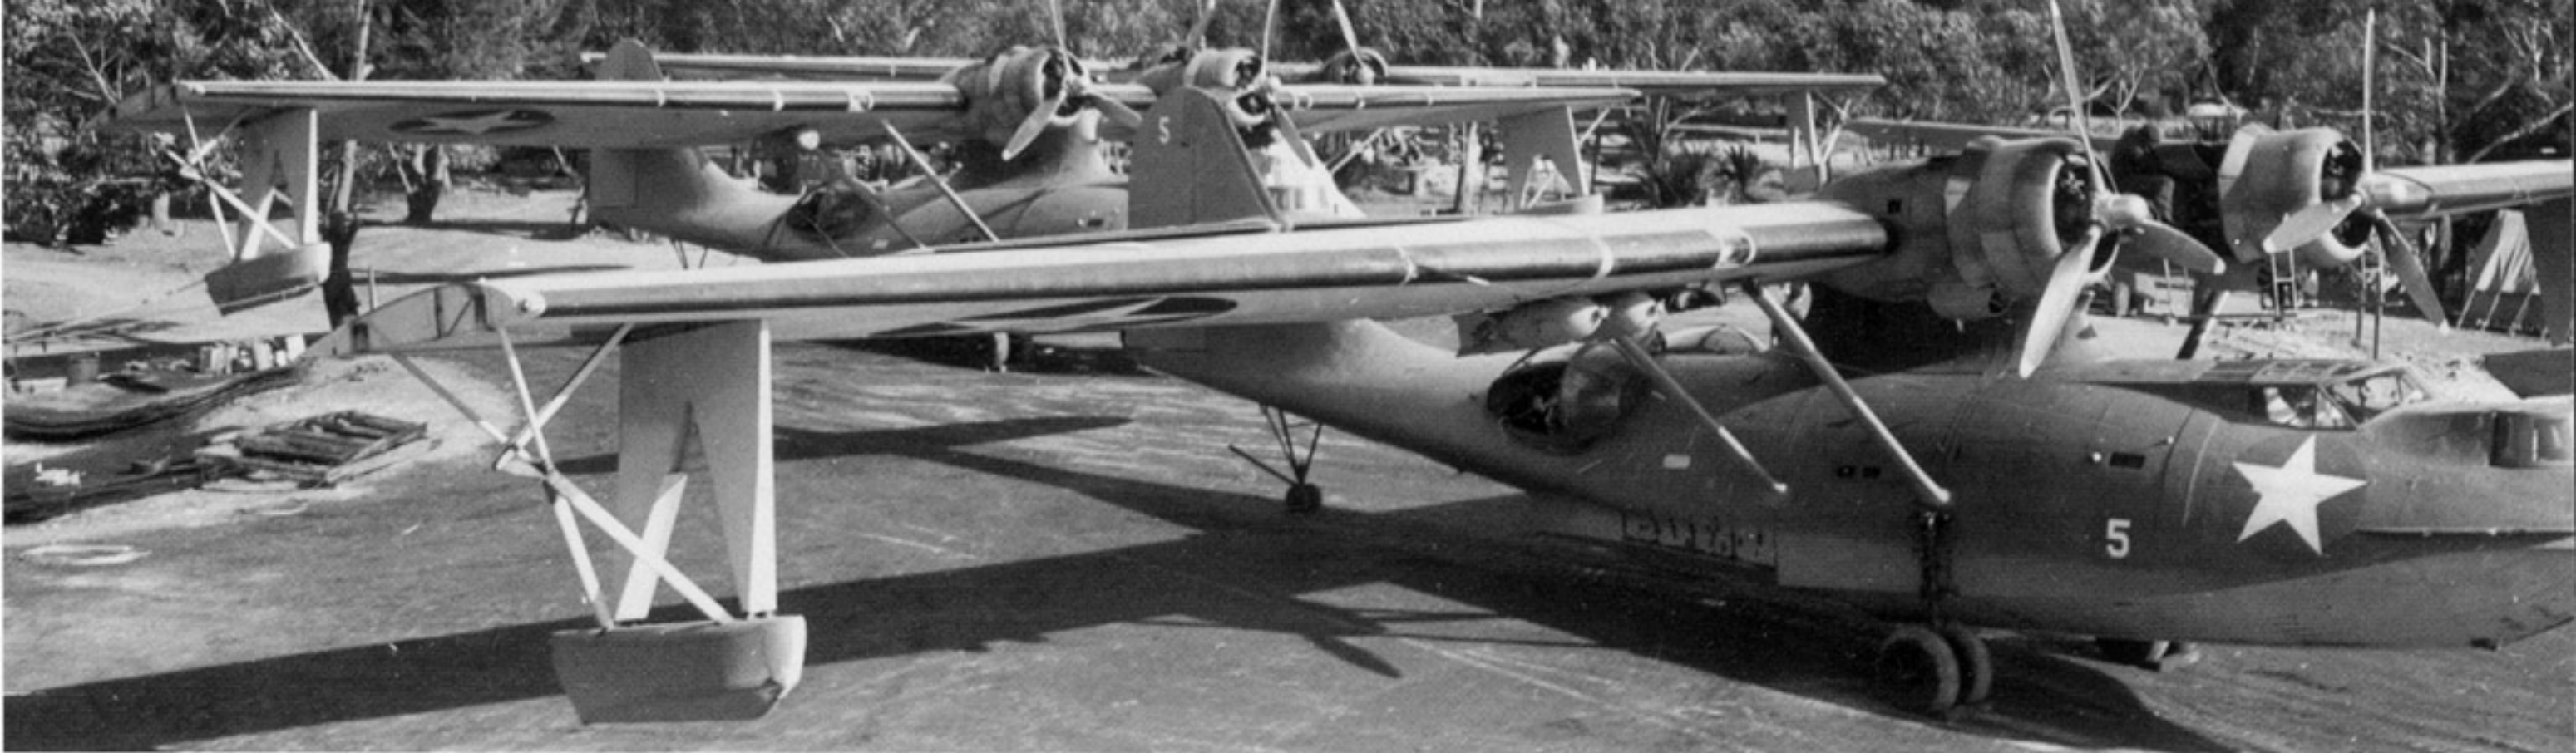
For ferry flights between bases, the main beaching gear and tail wheel were disassembled and stowed in the bunk compartment. The gear was plainly marked with right hand and left hand markings and tied down securely before takeoff. (USN)

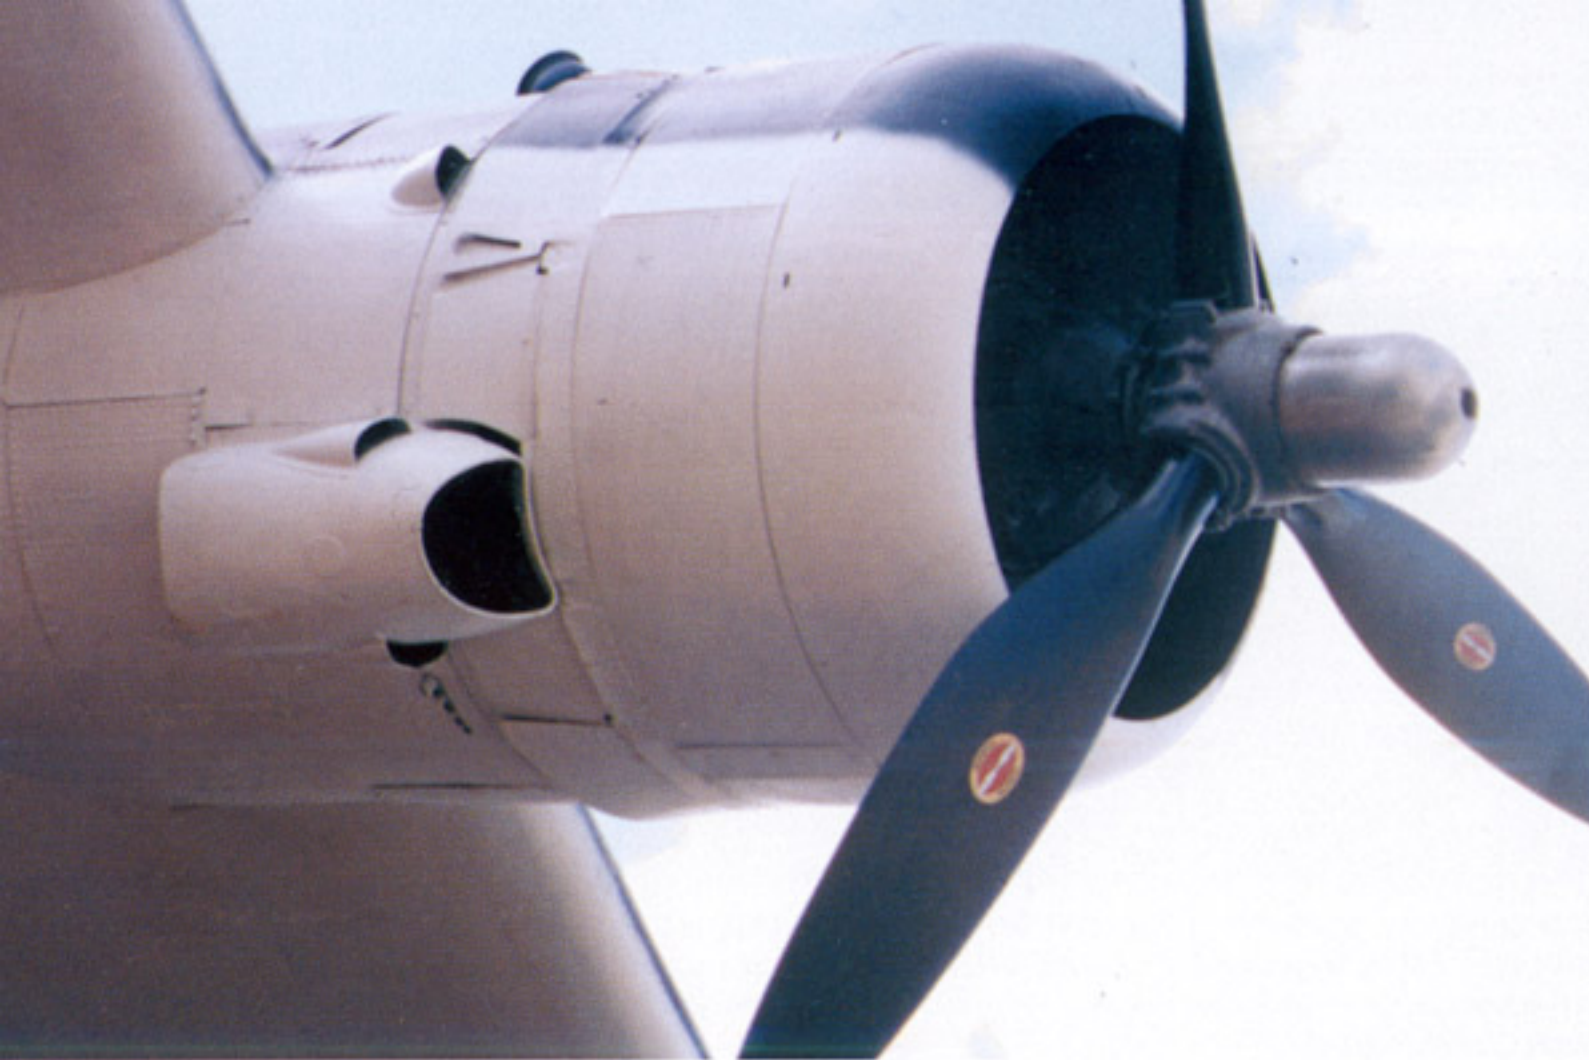
The starboard engine nacelle of a PBY-5A with the cowl flaps closed. The intake on the lower nacelle is the oil cooler housing with coolant vents on each side. The logo on the propeller blades is the company logo for the Hamilton Standard company. (Richard Dann)

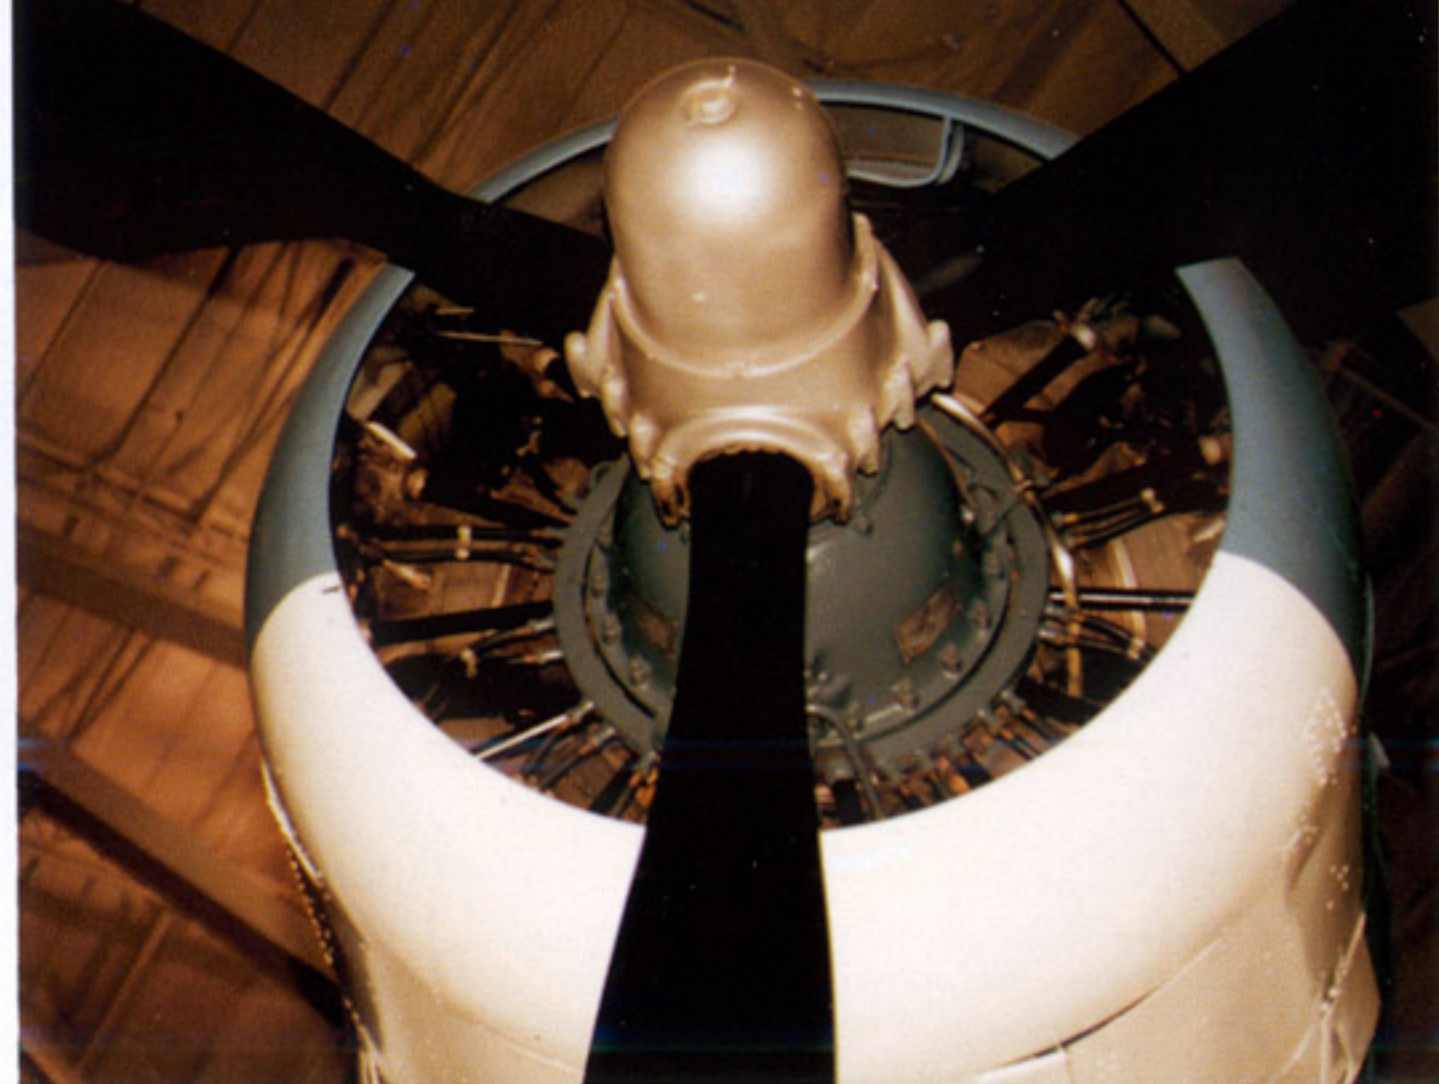
An engine and propeller of the USAF Museum's OA-10A. The Catalina used Pratt & Whitney R-1830-92 radial engine and a three blade Hamilton Standard Hudromatic full feathering propeller. (B.Ryle)
